**TEST REPORT
CROSS SECTION AND EVALUATION**

**BEST, Inc.
3603 Edison Place
Rolling Meadows, IL 60008**

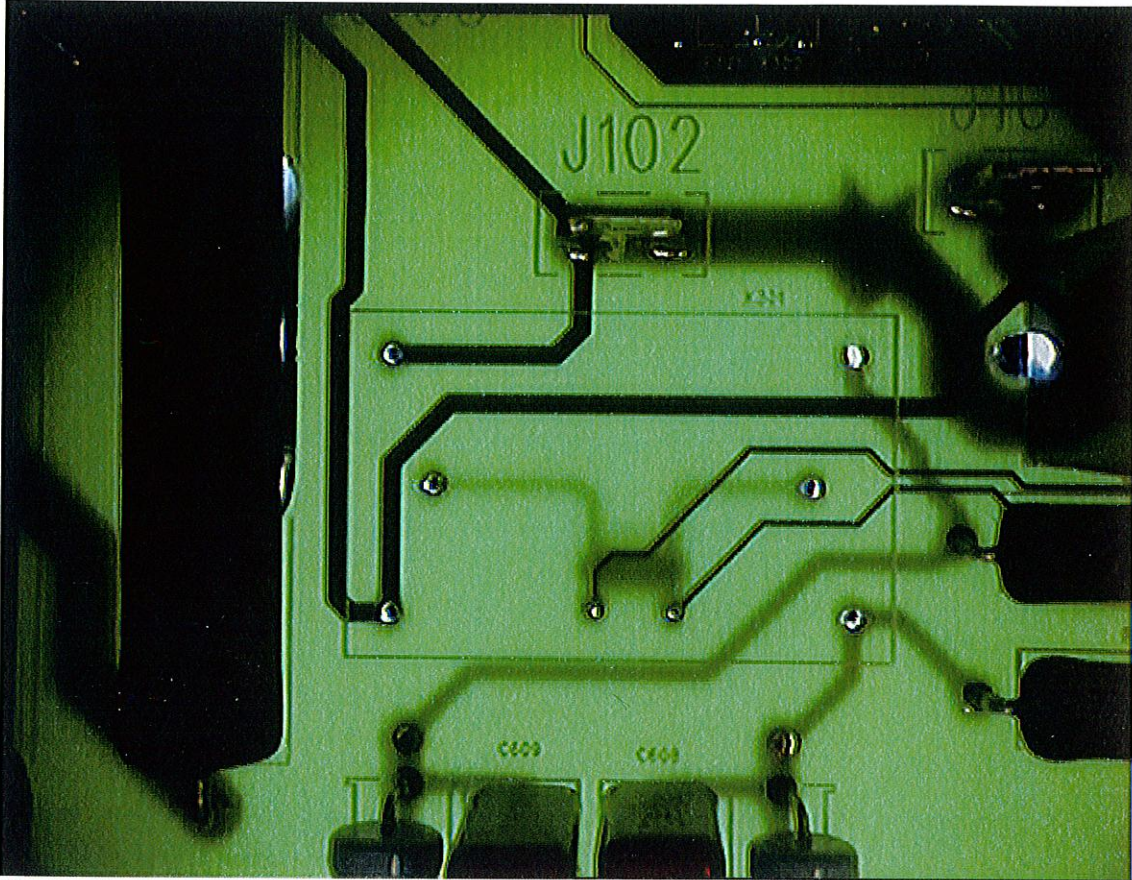
Illustration 1: S/N TB833036 was received with K301 removed. Back lighting reveals inner layer conductors.

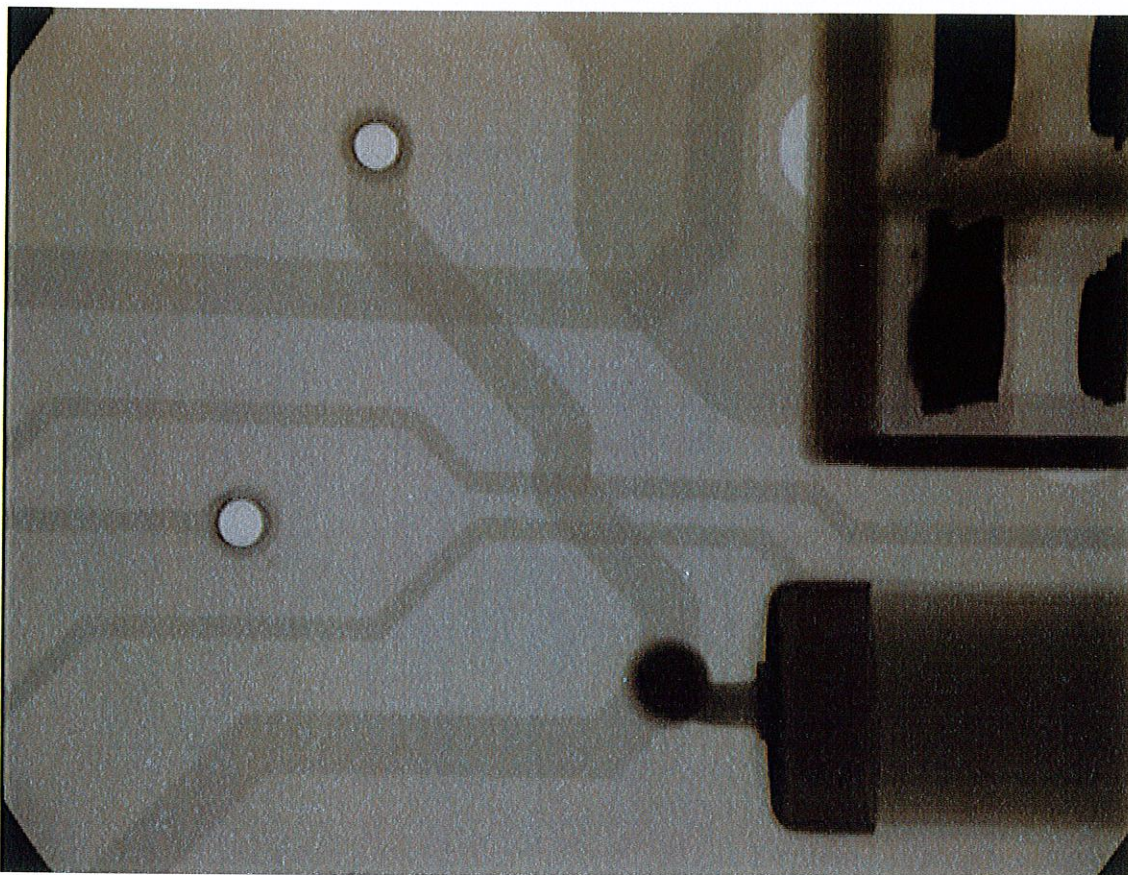
Illustration 2: S/N TB833036 was received with K301 removed. X-Ray image reveals inner layer conductors.

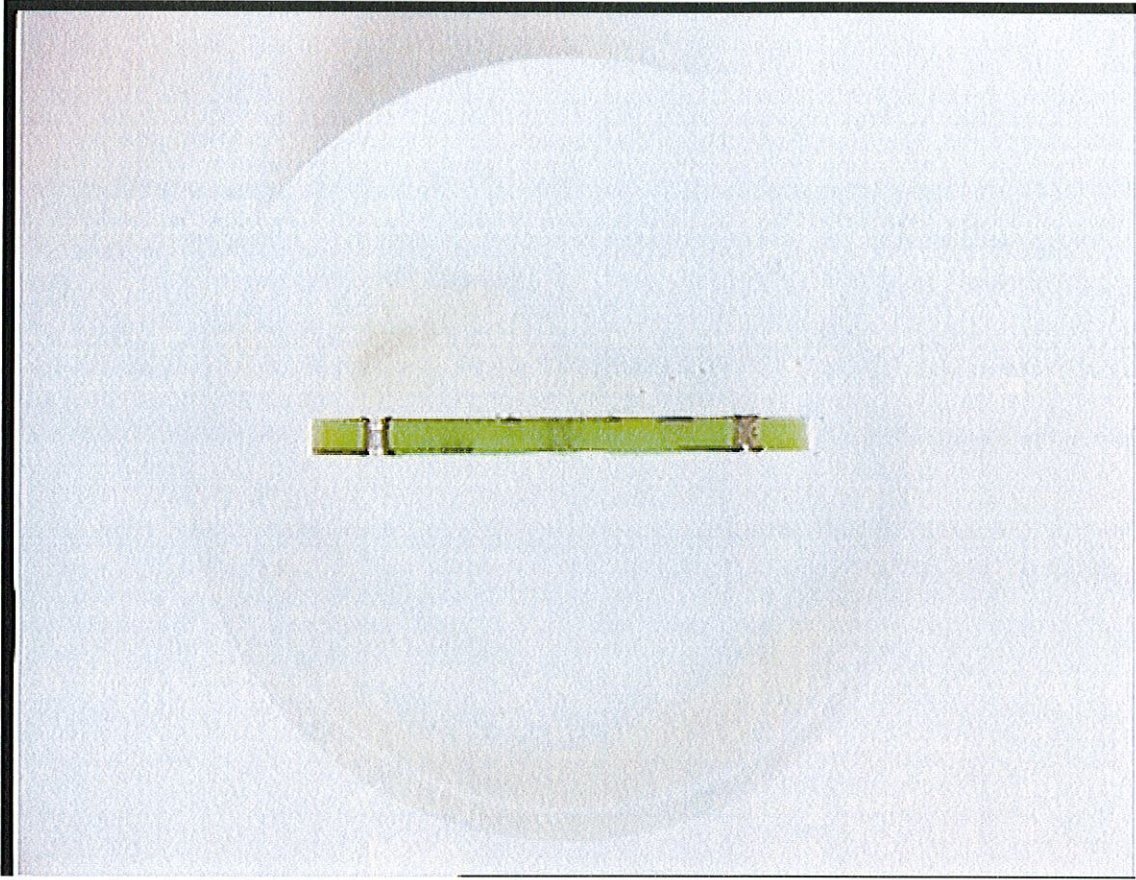
Illustration 3: S/N TB833036 was received with K301 removed. The plated through hole on the right is the targeted hole with a connection to R605.

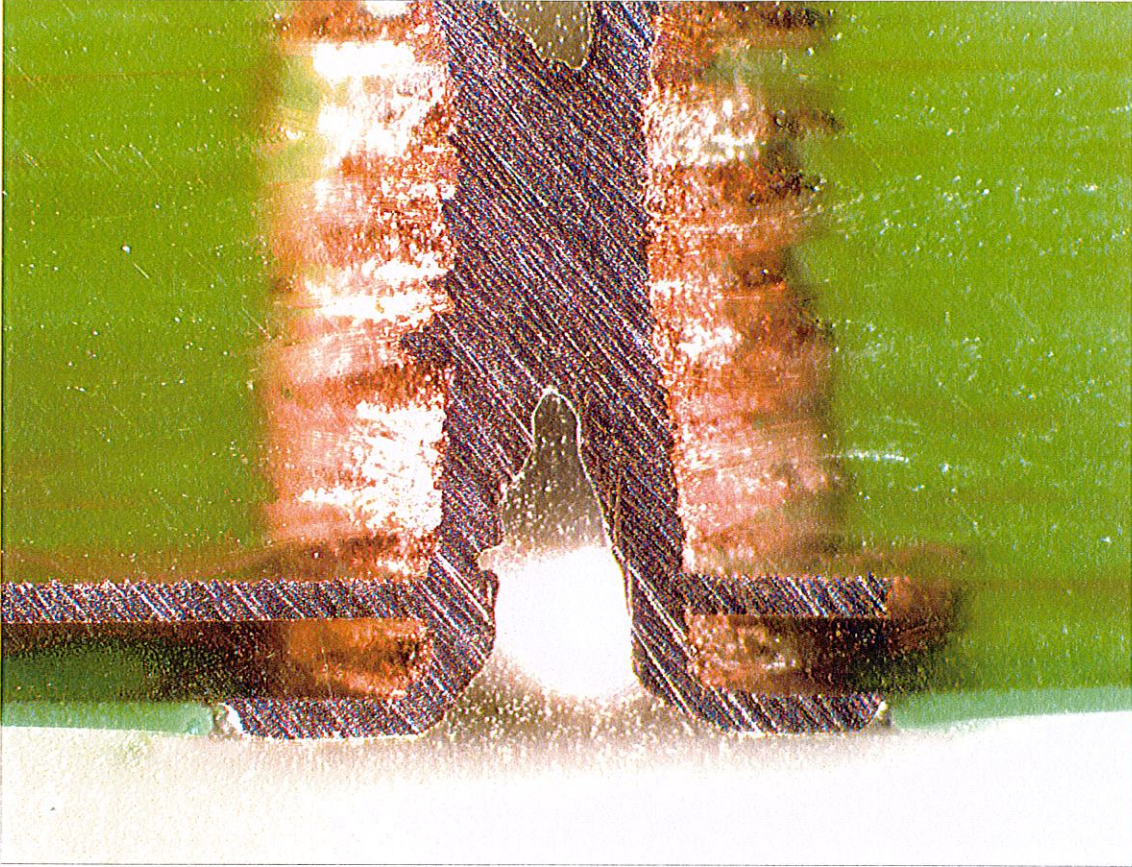
Illustration 4: S/N TB833036 50X magnification. Inner layer connection looks good.

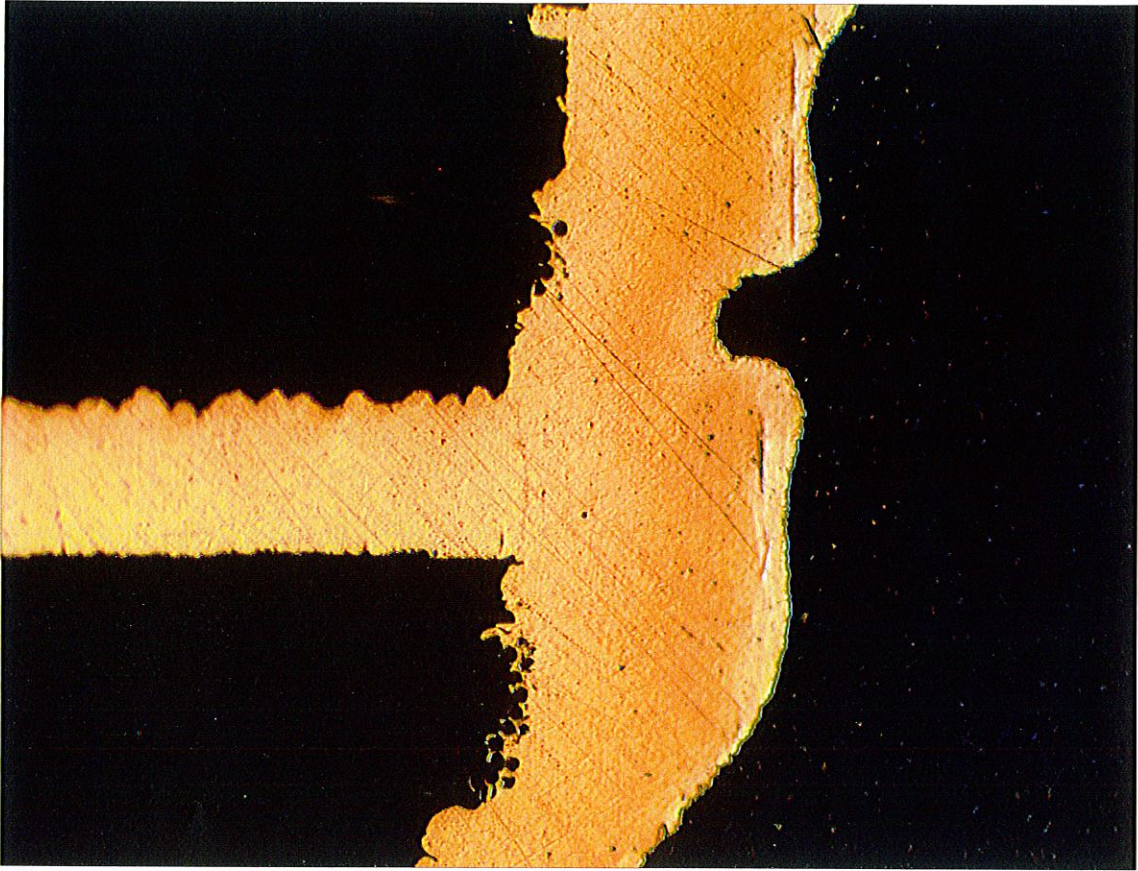
Illustration 5: S/N TB833036 200X magnification with DIC. Inner layer connection looks good.

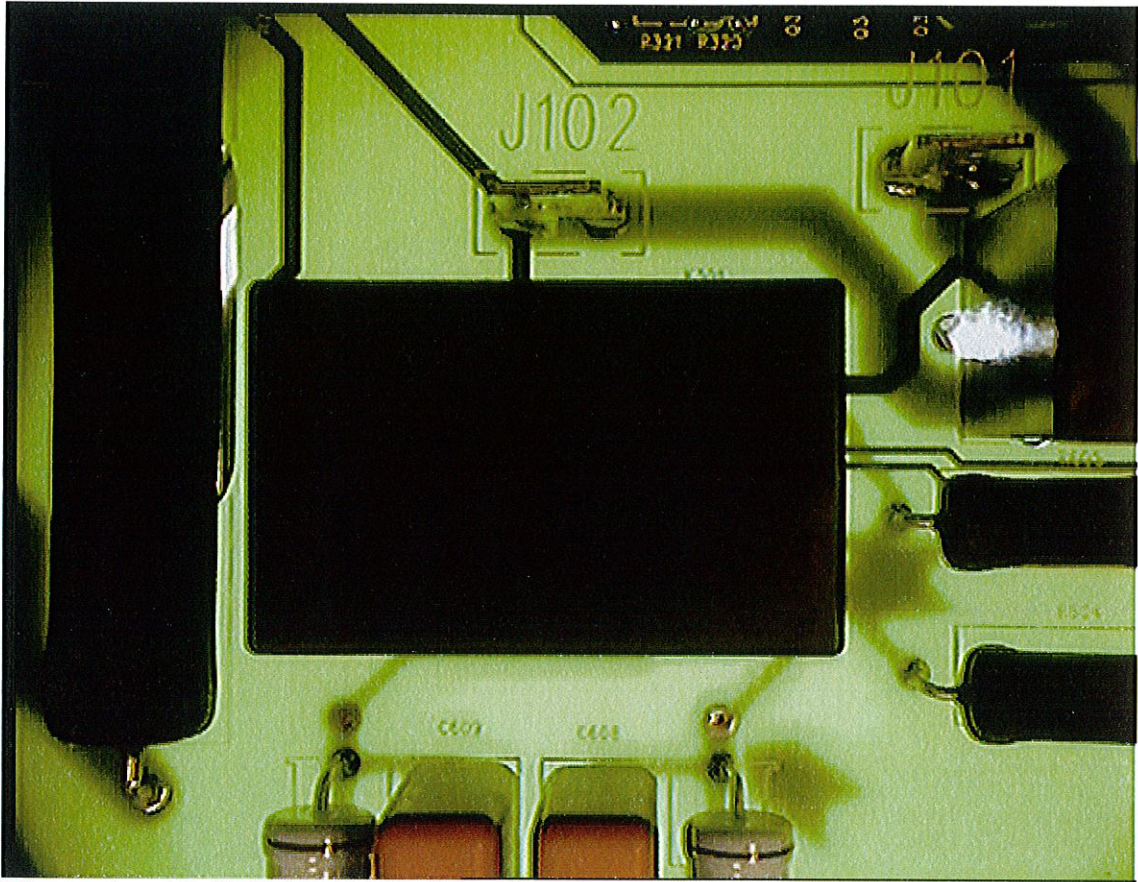
Illustration 11: S/N TB829199. Back lighting reveals inner layer conductors.

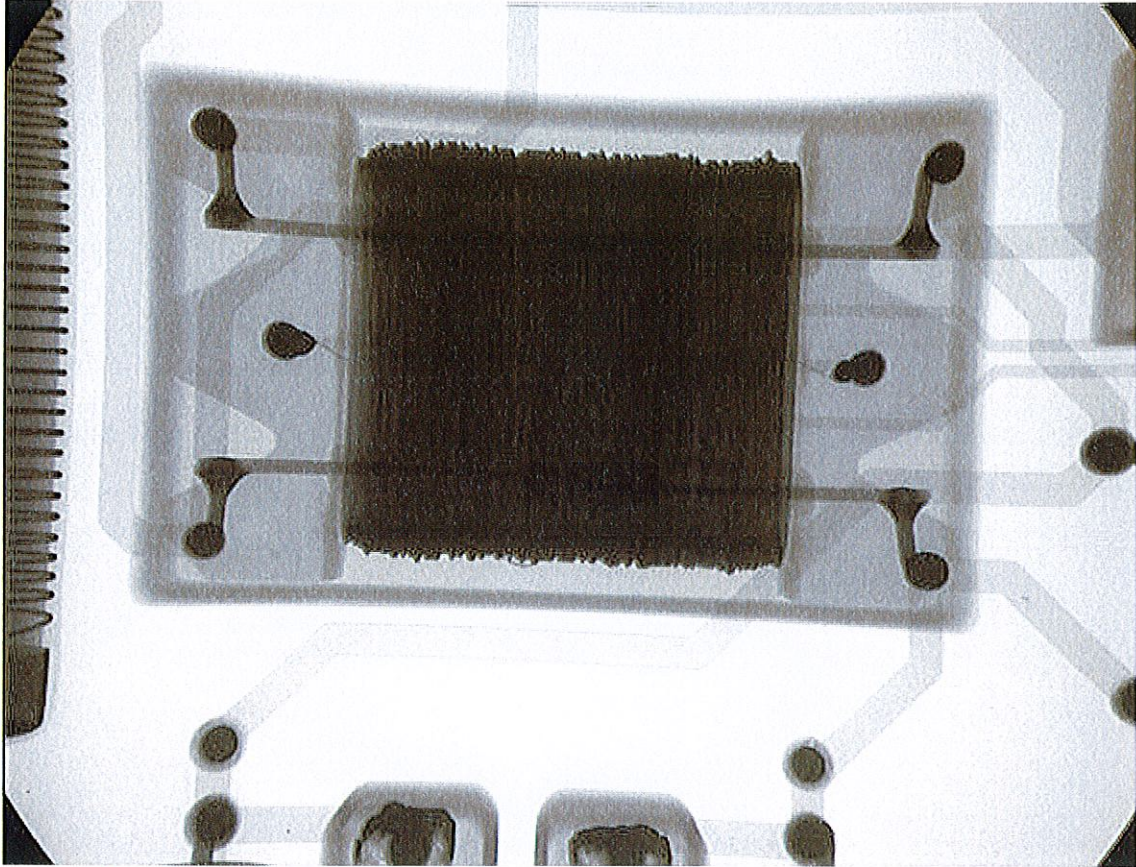
Illustration 12: S/N TB829199. X-Ray image reveals inner layer conductors.

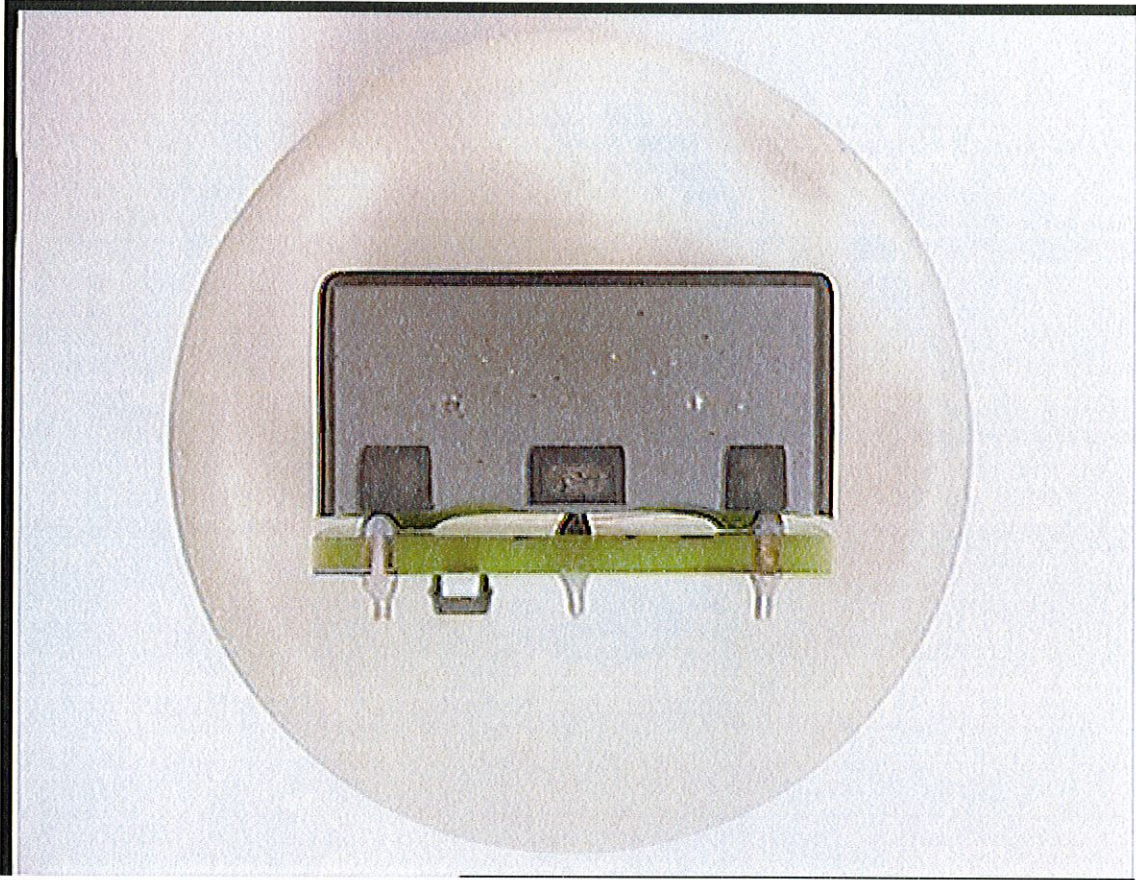
Illustration 13: S/N TB829199. The plated through hole on the left is the targeted hole with a connection to R601.

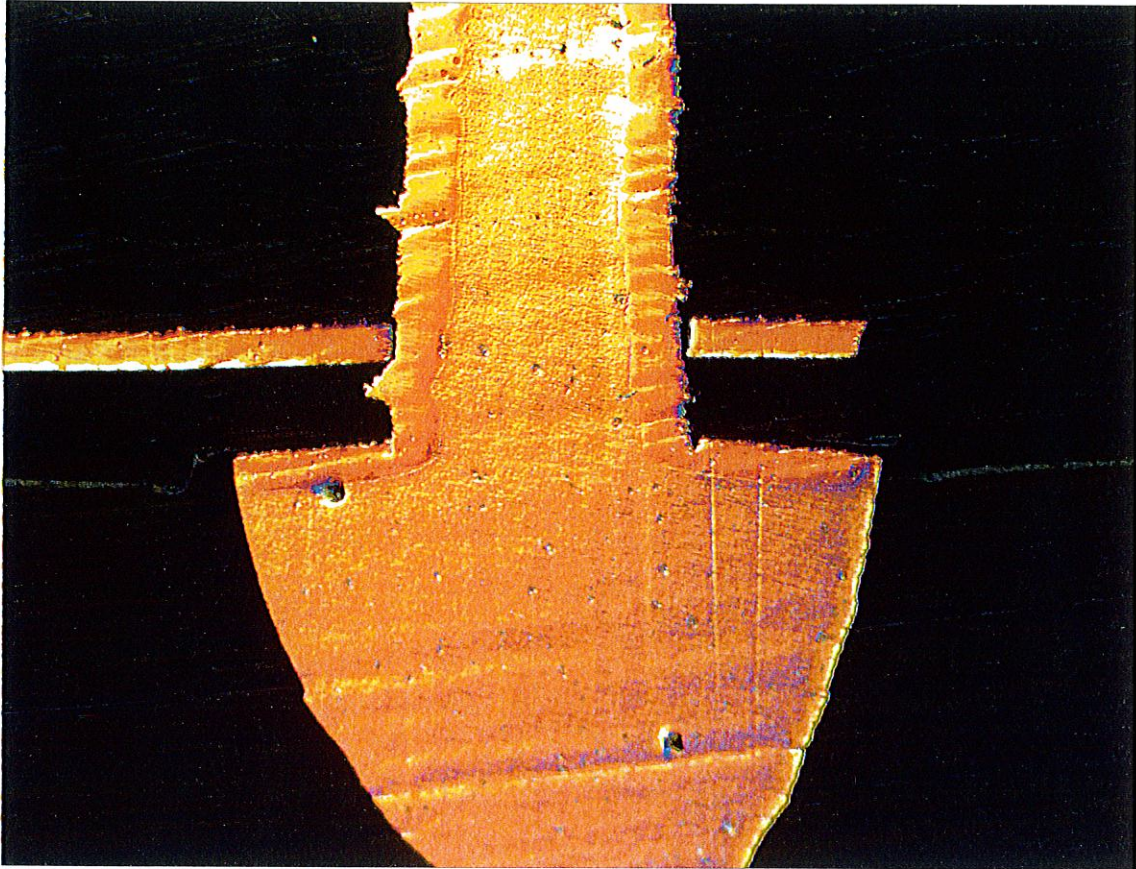
Serial numbers TB902038 and TB833036 were found to be non-remarkable. Serial number TB829199 exhibited an open where the inner layer pulled away from the barrel of the hole wall. It appears that epoxy smear removal was performed utilizing the negative etchback method. The degree of negative etchback was consistent with the target condition of IPC-A-600. The assembly that exhibited an open, also exhibited a slight degree of pad lifting. This could be indicative of excessive heat being applied locally, maybe as the result of a rework operation.

Illustration 14: S/N TB829199 50X magnification with DIC. Inner layer have separated from the copper of the hole wall.

It should be determined if any inner layer opens are occurring during the manufacturing process or if they are occurring during some additional process steps. A review of all hand solder operations should be performed to ensure that the inner layers are not being damaged during these processes.

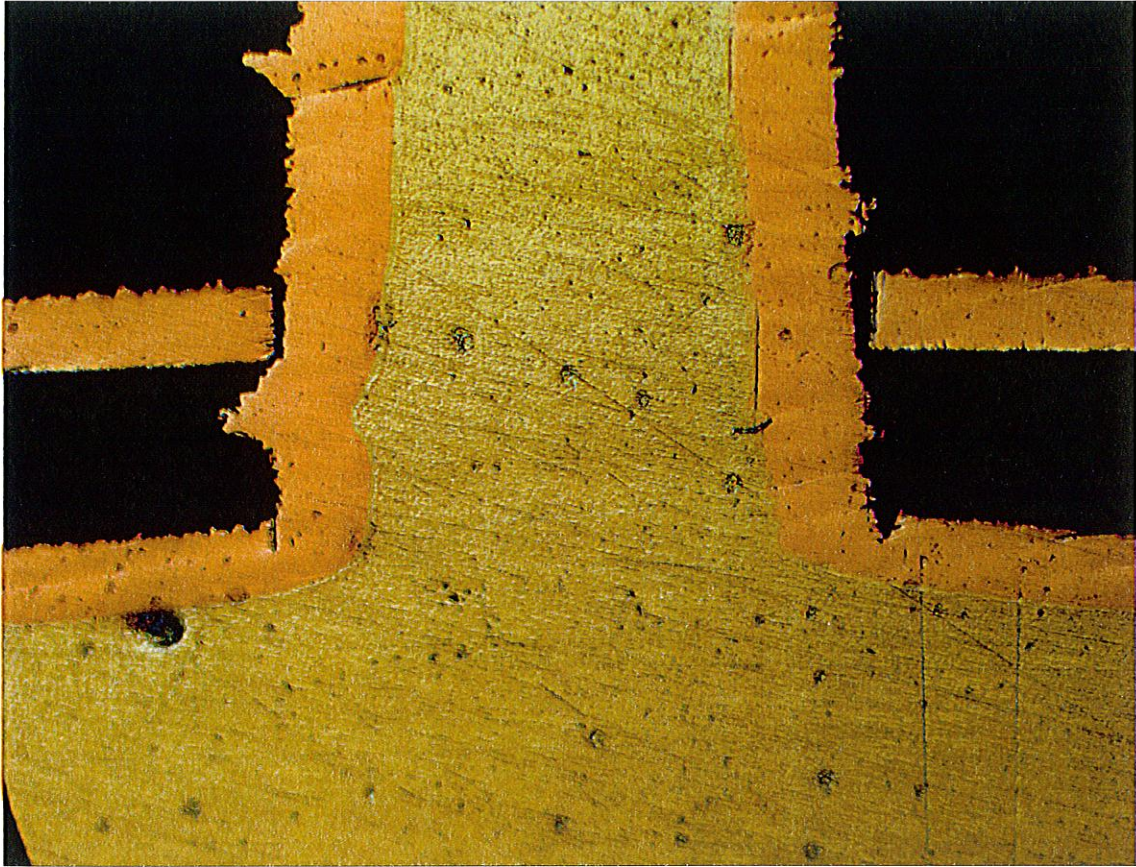
Illustration 15: S/N TB829199 100X magnification with DIC. Inner layer have separated from the copper of the hole wall.

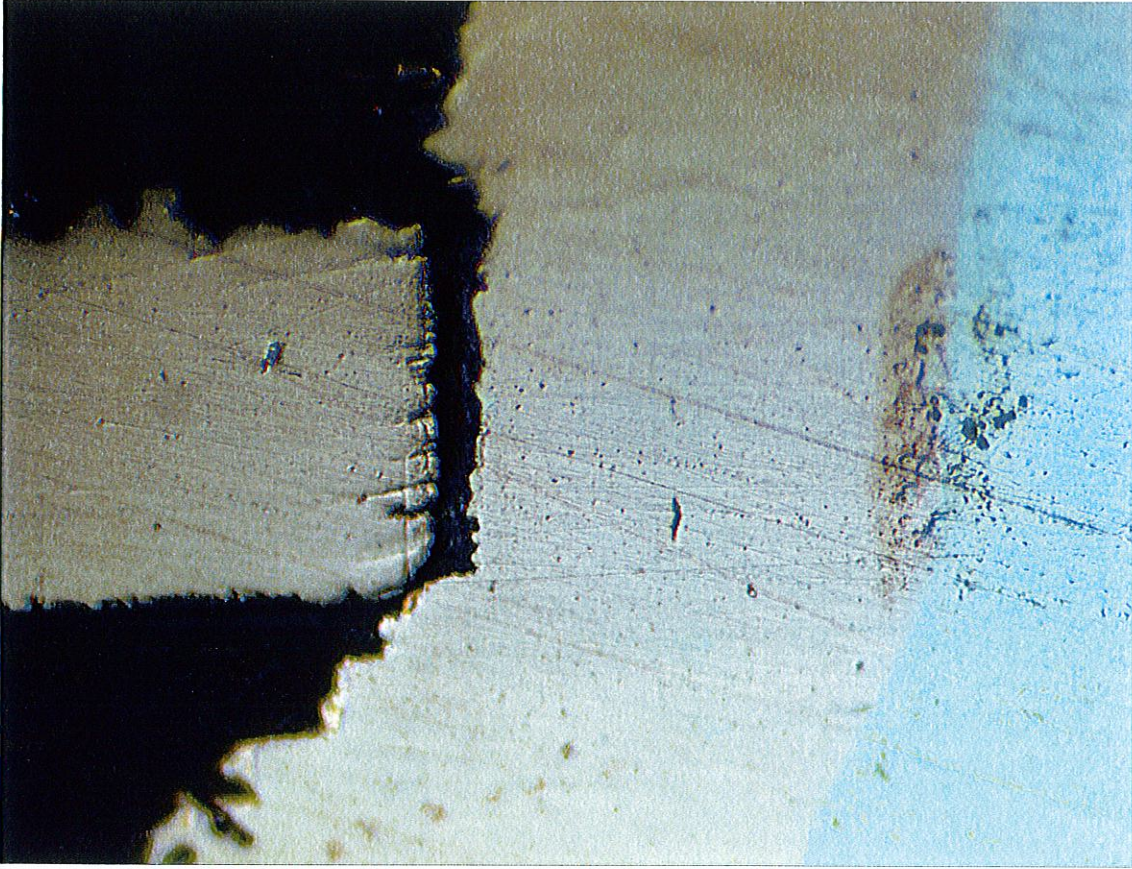
Illustration 16: S/N TB829199 500X magnification with DIC. Inner layer have separated from the copper of the hole wall.
