Evaluation Report

**Prepared By:
BEST Inc.
3603 Edison Place
Rolling Meadows, IL 60008**

A shipment of 30 cables was received from ABC Company Inc. at BEST Inc. for inspection. The cables were inspected per IPC-A-620 Class 2 criteria. All 30 cables were found to be defective. The defect conditions are listed below.

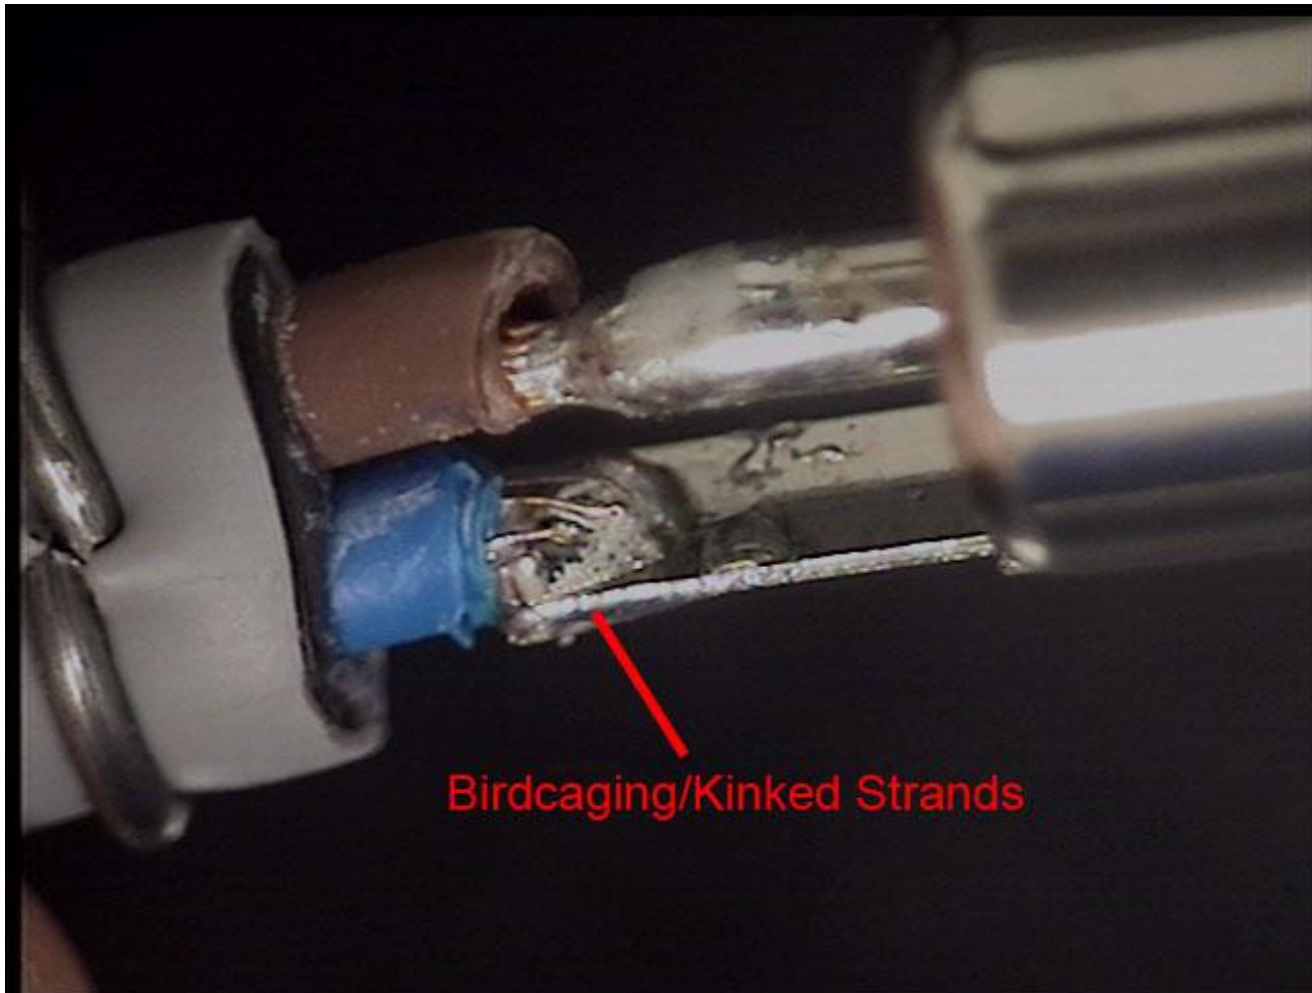
Conductor Deformation/Birdcaging:

Per IPC-A-620 section 3.3 criteria, any wire whose general spiral lay or whose wire strands extend beyond the wire insulation (birdcaging) or whose strands are kinked is considered a defect. Almost all of the cables had at least one of these defect conditions. In particular, the blue wire had severe birdcaging in many cases. The reason for this is because the wire was not tinned prior to the attachment to the terminal. See Fig.1 and Fig.2

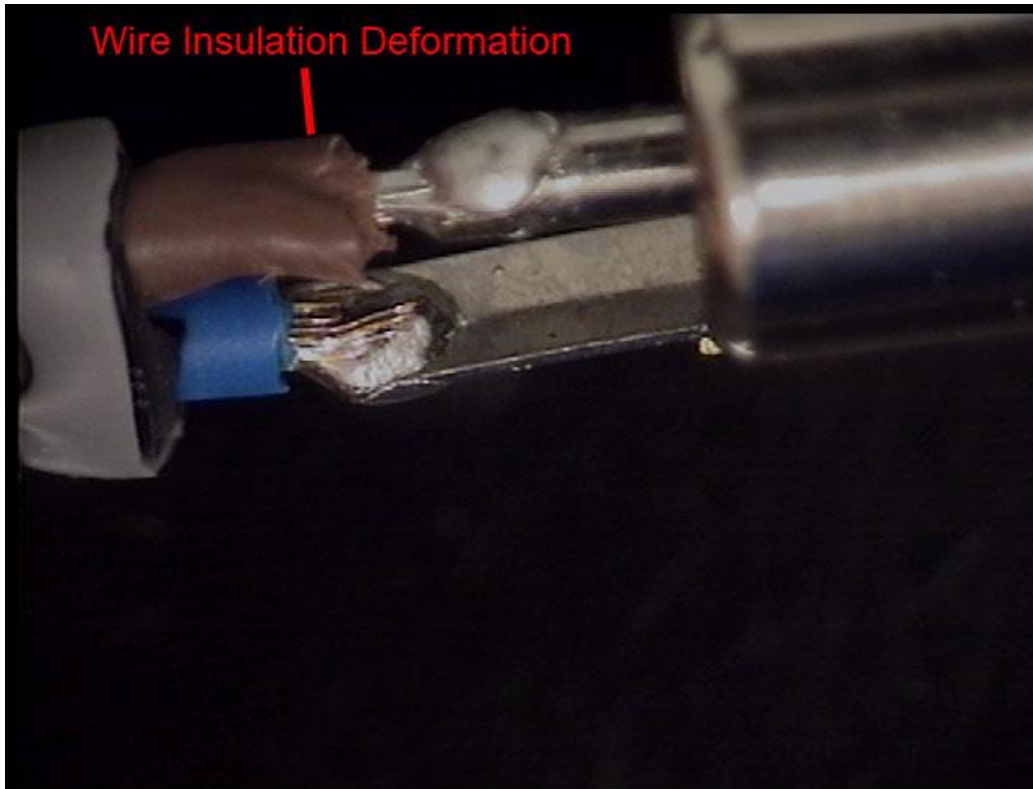
Fig.3

Wire Insulation Deformation:

Per IPC-A-620 section 3.5 criteria, any wire insulation that has cuts, breaks, cracks, splits or whose insulation thickness is reduced by more than 20% is considered a defect. Many of the cables exhibited these defects. In particular, the brown wire had many instances where the insulation was reduced by more than 20%. See Fig.3.
